White Paper Report

Implementing Sustainability Strategies for the Abbe Museum's Collections Environment

Grantee Institution: Abbe Museum

BUILDING AIR-BARRIER EVALUATION REPORT—ABBE MUSEUM

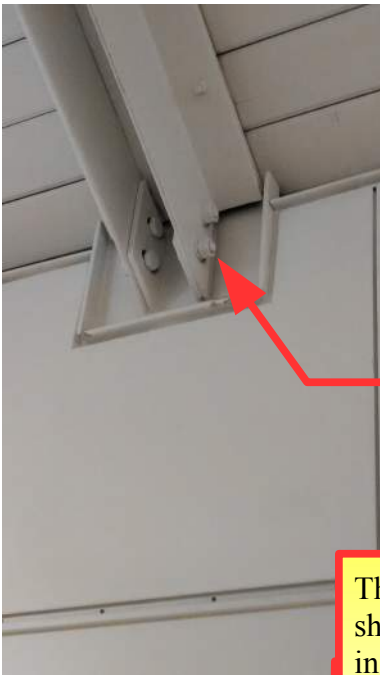
Julia Clark pointed out the 2 areas where ceiling leaks have occurred—at the HVAC supply duct penetrating the upper east sloped-ceiling, and along the east-eave at a steel roof-framing bracket, above the common wall with the adjacent hallway. These leaks occur during the heating season only.

This is one of the identified leak areas. Note metal adjacent to leak.

Priority	Retrofit/Air-sealing recommendations
High	<p>EAVE—In the attic, remove the lower 6-foot section of foamboard insulation (2 layers) to expose the membrane over the ceiling. Remove all debris and insulation at building assembly transition to opposing slope and wall of computer room. Seal all penetrations in the membrane with flexible adhesive sealant. Install new 6" polyisocyanurate foamboard (in 2 or 3" alternating layers) from pitch change to within 1-foot of transition above common-wall with hallway below. Install 4" SPF (in 2 applications of 2") to exposed ceiling membrane and building-assembly transition (to either wall or sloped-ceiling).</p> <p>SUPPLY DUCT—cut back existing insulation roughly 1-foot from edge of duct/duct-insulation. Air-seal duct penetration in the ceiling with flexible adhesive caulking. Be sure to remove insulation at the bottoms of the adjacent valley rafters, and air-seal all cracks/holes/seams with canfoam. Install 4" SPF (in 2 applications of 2") to exposed ceiling encasing rafter-bottoms/plate.</p>

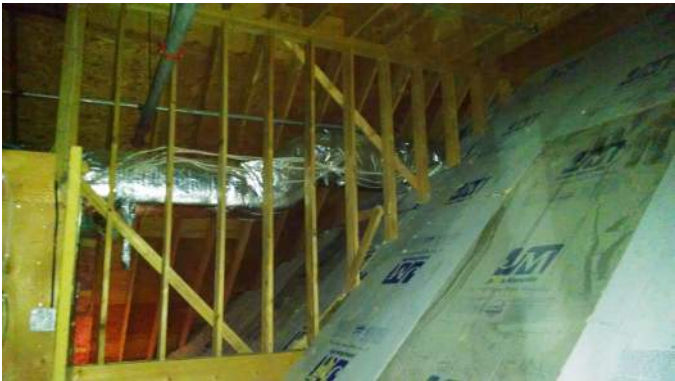
This is the attic-side of the same ductwork.

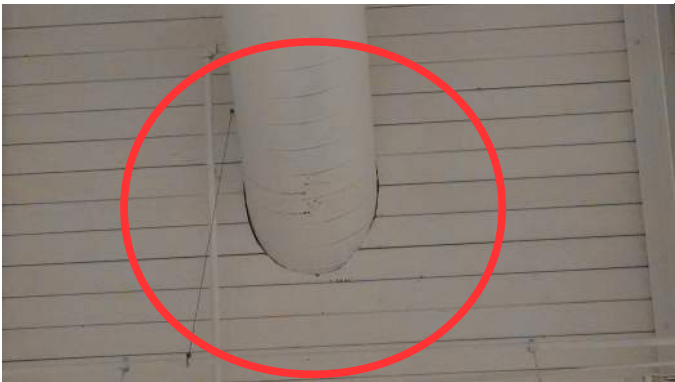
Site of ceiling leak at HVAC supply ductwork. Remove insulation inside of red-line in attic for proper air-sealing.

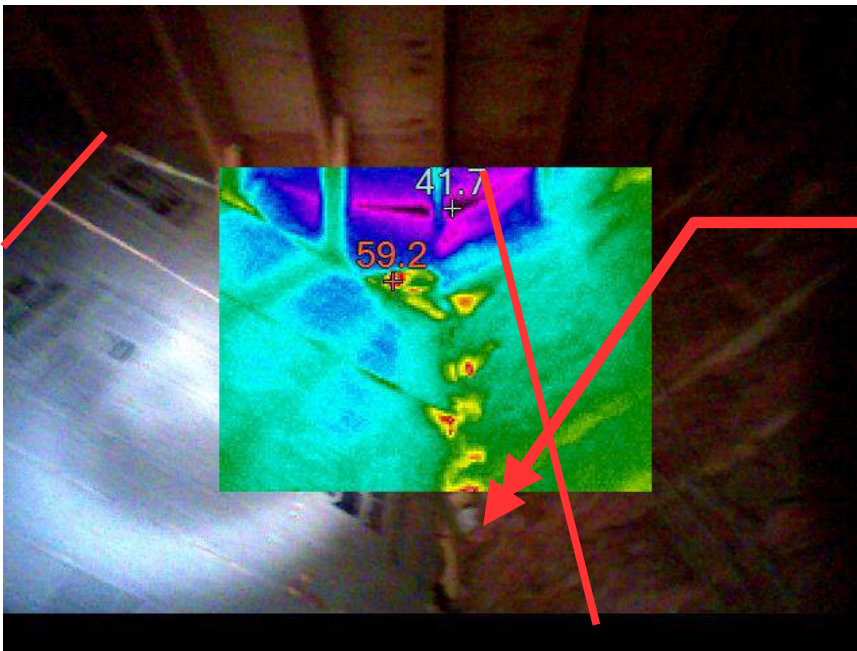
East-facing eave of exhibit room, above common-wall with hallway.

Location of pitch-change on east-facing exhibit room ceiling. Currently the 2 layers of foamboard are not contacting the ceiling surface because the sheets are spanning transition, instead of being cut/fit and sealed to ceiling. Note seams not sealed.

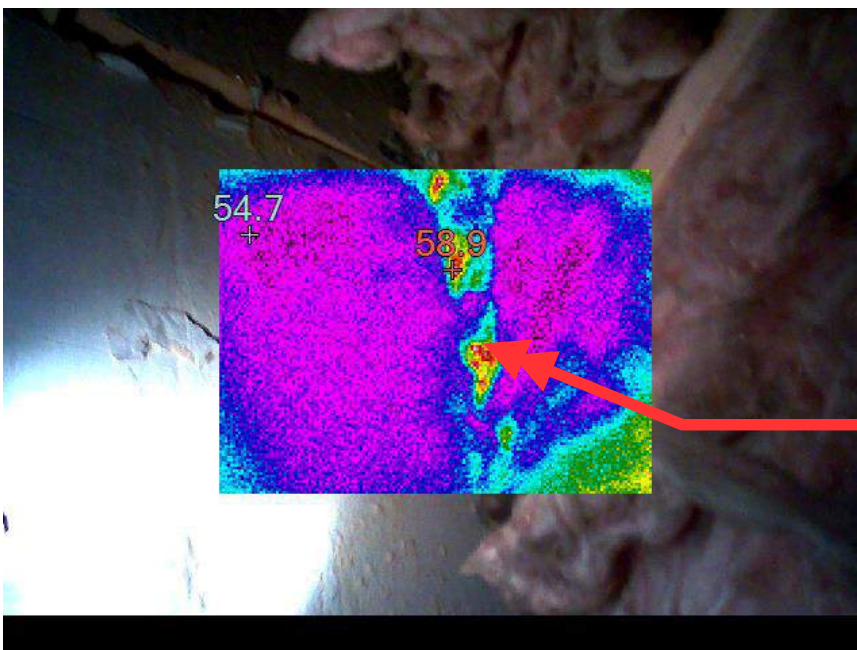
East-facing eave of exhibit room, adjacent to 2nd story computer room.

Location of "eave" at intersection with framed-wall of 2nd story computer room. This foamboard is heavily impacted, poorly air-sealed and is discontinuous where it intersects the wall framing. Remove foam up to the 6-foot mark, pulling the fiberglass and debris, then subsequent SPF installation should eliminate this problem.

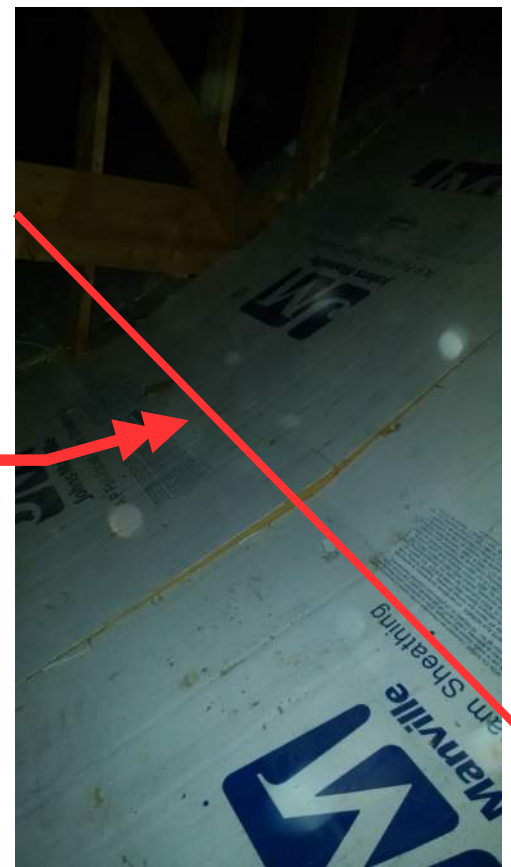
The eave-leak issue is both an air-barrier and thermal barrier breach. Therefore complete removal of foamboard to pitch change (at red-line left) and removal of fiberglass along reverse slopes (to the right red-line) followed by comprehensive membrane-sealing, air-sealing, and re-insulation should fix the water leaking in, and air leaking out.

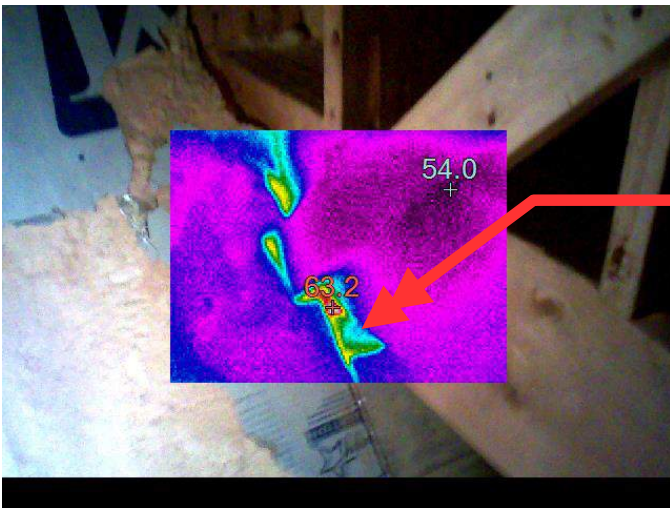
This image shows conditioned air exfiltrating through breaches in the membrane and the poorly air-sealed foamboard adjacent to and over the associated roof-support framing.

Priority	Retrofit/Air-sealing recommendations
High	<p>ROOF SUPPORTS—In the attic, atop and along both sides of the 2 roof-support structures, remove at least 1-foot of foamboard to expose ceiling membrane—from the ridge down to the eave (above the common-wall with hallway). Repair/seal membrane, air-seal any gaps/seams, then install 4" SPF (in 2 applications of 2") to exposed ceiling encasing bottom-plate of roof-support.</p> <p>VALLEYS—Along both north and south valleys—where perpendicular roof overlays/intersects the sloped-roof of the exhibit hall, cut back existing insulation roughly 2-feet from valley point. Air-seal holes drilled into bottoms of rafters (intended to connect the bottoms of the adjacent exterior-exposed slopes to the ridge vent, but are ineffective in their current location), air-seal all framing seams/gaps with canfoam. Install 4" SPF (in 2 applications of 2") to exposed ceiling encasing rafter-bottoms/plate.</p>

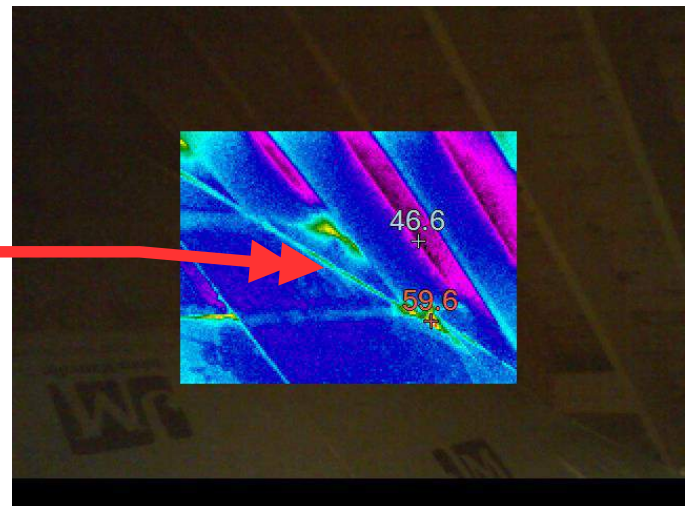
Looking west in the attic toward the northern valley which overlays the exhibit room. Yellow and reds show air-leaks associated with the framing intersection between the exhibit room ceiling/roof and the connector roof.

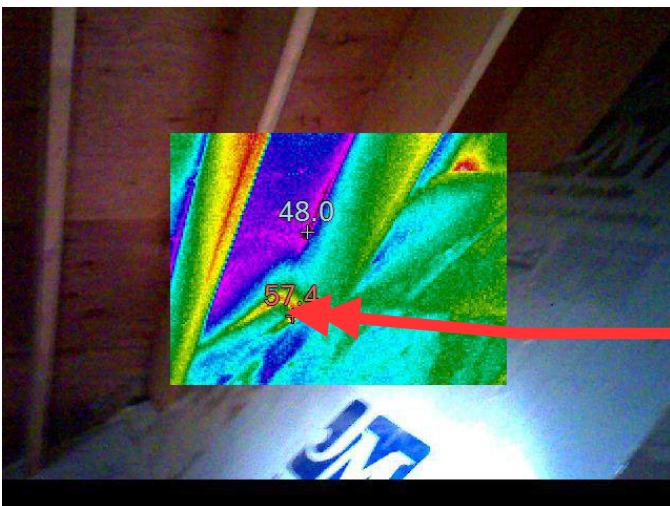
Looking south in the attic toward the southern valley which overlays the exhibit room. Again, yellow and reds show air-leaks associated with the framing intersection between the exhibit room ceiling/roof and the connector roof.

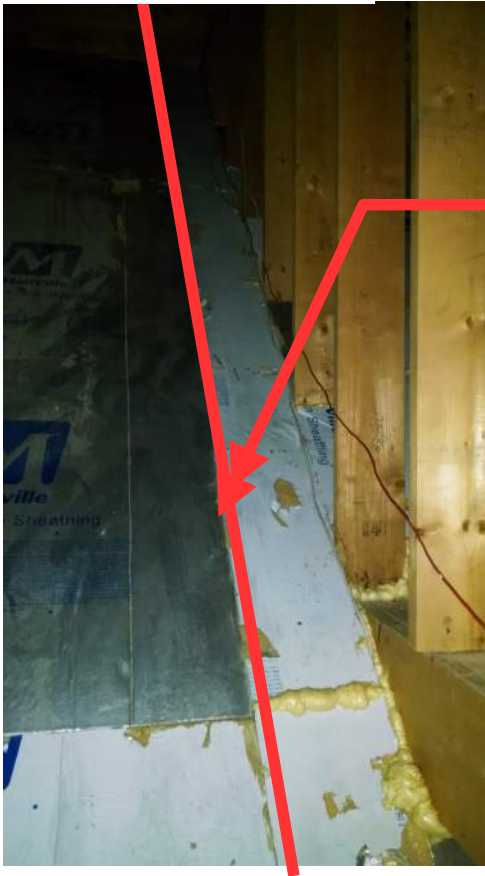
Looking west up one of the roof-support structures. Note the high concentration of seams in the foamboard. Remove existing foamboard to the red-line, seal membrane, air-seal gaps, cracks and seams, then install 4" SPF over exposed ceiling and bottom plate of the support-wall.

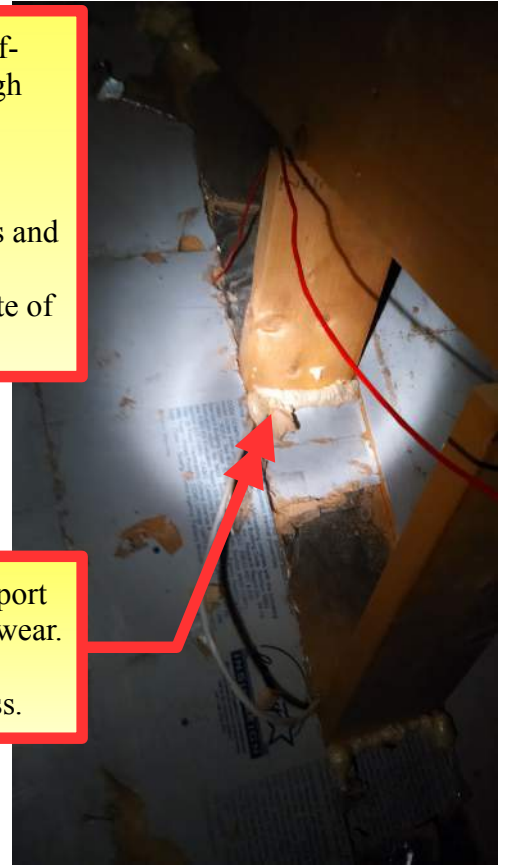
Close-up of bottom of roof-support showing seams, and insulation wear. SPF will effectively encase the framing to prevent air/vapor loss.

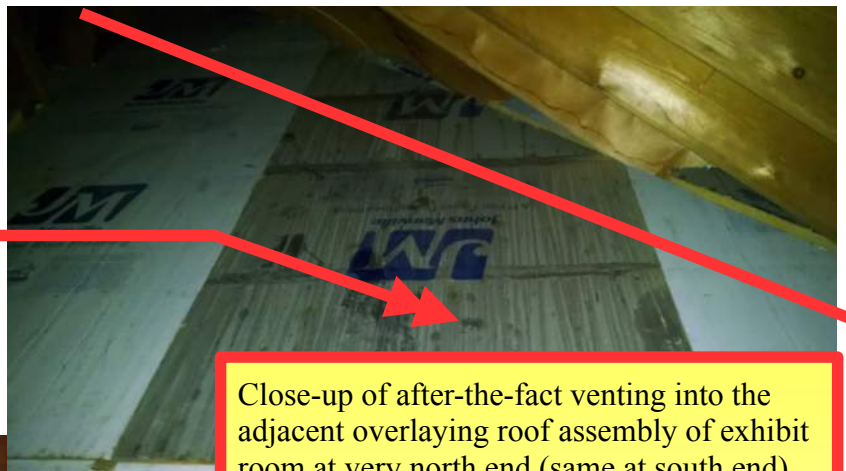
At the north end of the attic overlaying the east-facing exhibit room sloped-ceiling. North-facing valley rafter at top-right. Note the amount of condensate drool down the face of the foamboard. This north-facing roof is generally a lower temperature, that coupled with a restricted air-pathway (see below), creates a back-up of water vapor conducive to condensation. Cut back foamboard to red-line and treat as with the roof-support-wall.

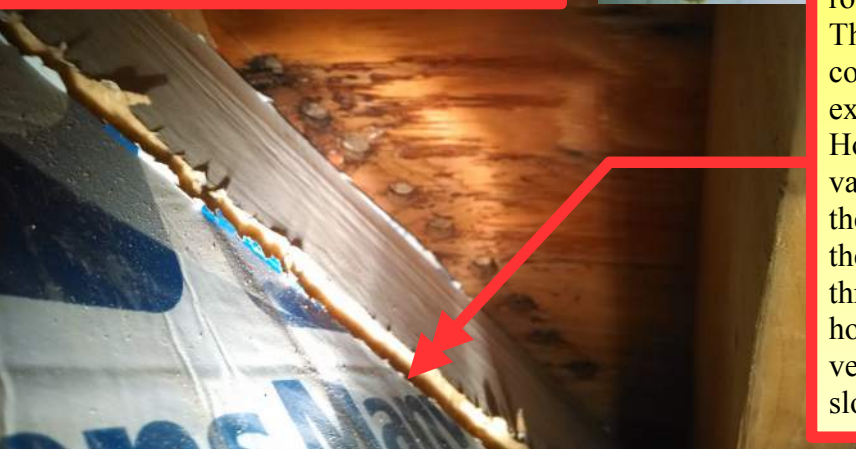
Close-up of after-the-fact venting into the adjacent overlaying roof assembly of exhibit room at very north end (same at south end). These holes are drilled all along the valley to connect and allow the stranded roof cavities exposed to the exterior to ventilate. However, moist attic air accumulates in these valley pockets, some of which exhausts into the adjacent sloped ceiling cavities through the drilled holes, condensing on it's way through the restricted, cold pathway. These holes should be sealed, and an alternative ventilation strategy proposed for the stranded slopes.

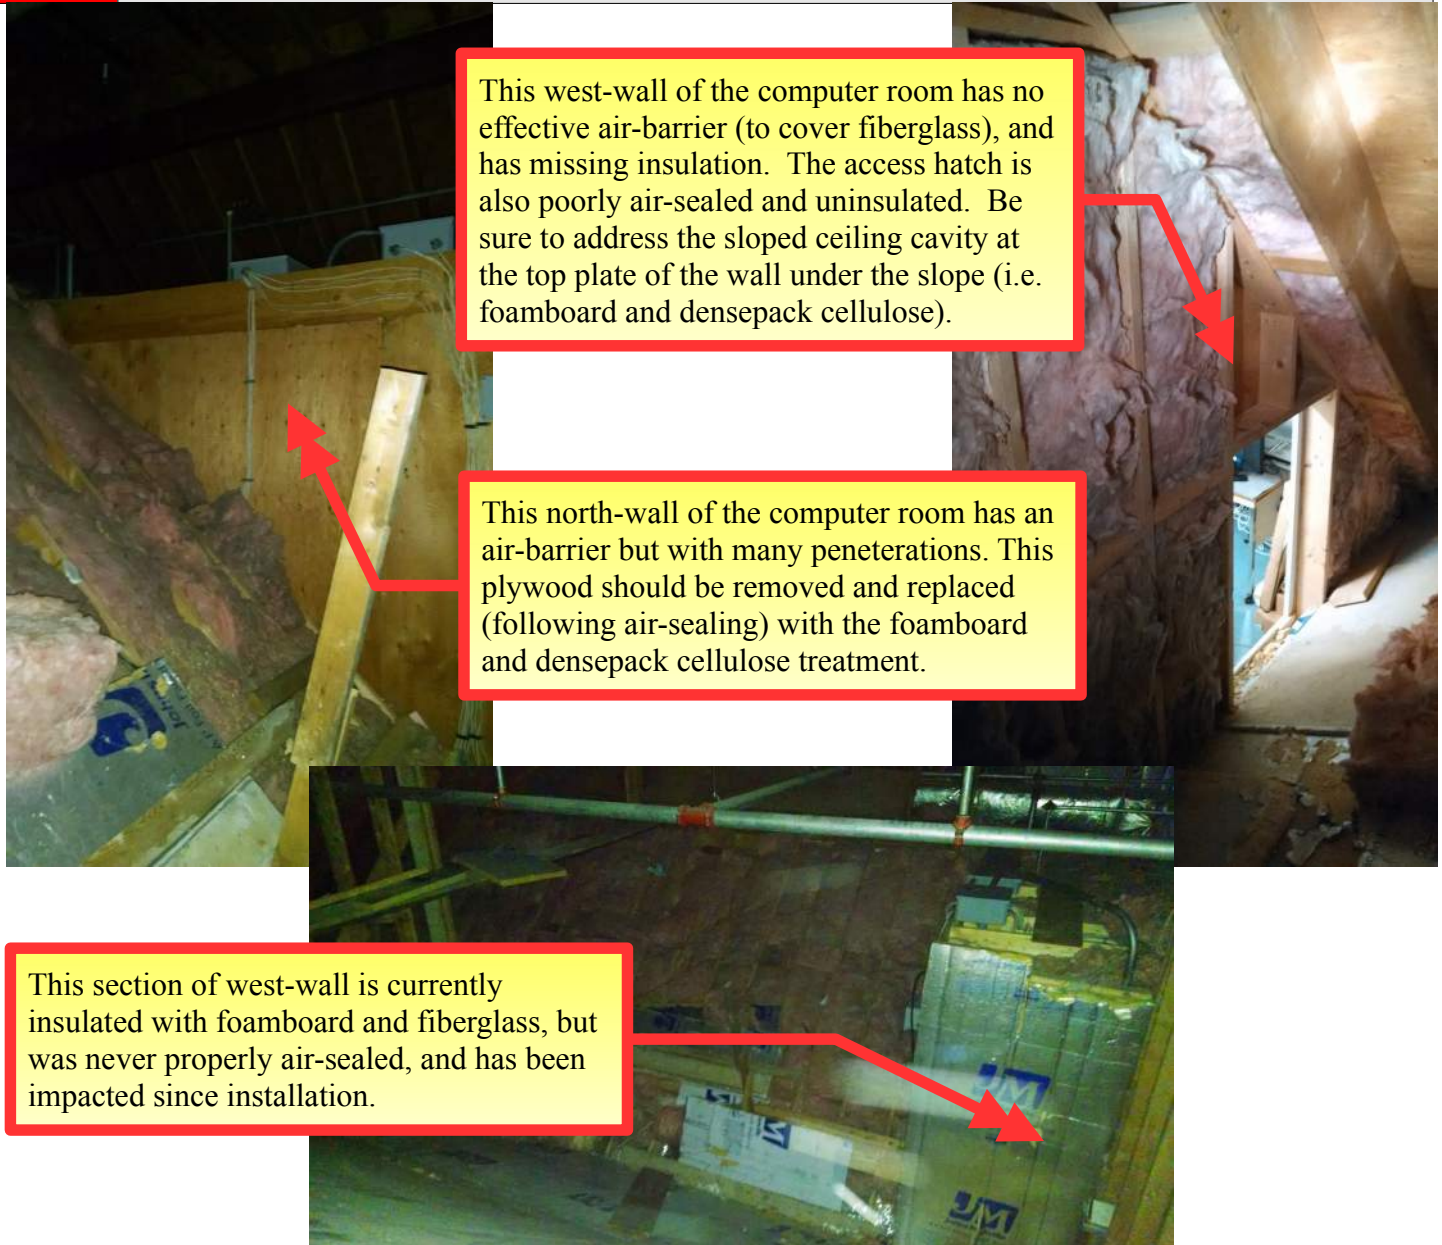
Priority	Retrofit/Air-sealing recommendations
High	<p>COMPUTER ROOM WALLS—<i>These walls have many penetrations, poorly installed and incomplete insulation, and contribute to heat-loss to the adjacent attic space. In the attic, remove all existing fiberglass batt insulation from the west and north-facing wall cavities (north wall will require plywood-removal).</i></p> <ul style="list-style-type: none"> • <i>Air-seal penetrations in the walls with canfoam/caulking,</i> • <i>create insulation dam at tops of wall cavities (west-wall),</i> • <i>air-seal seams at ceiling drywall above, exterior corner of room, and at the bottom of wall (if not completed already in above recommendation).</i> • <i>Then, install 1" Thermax foamboard to the attic-side of wall cavities, with cap-nails/strapping to secure, and in-fill prepared wall cavities with densepacked cellulose (r-27).</i>

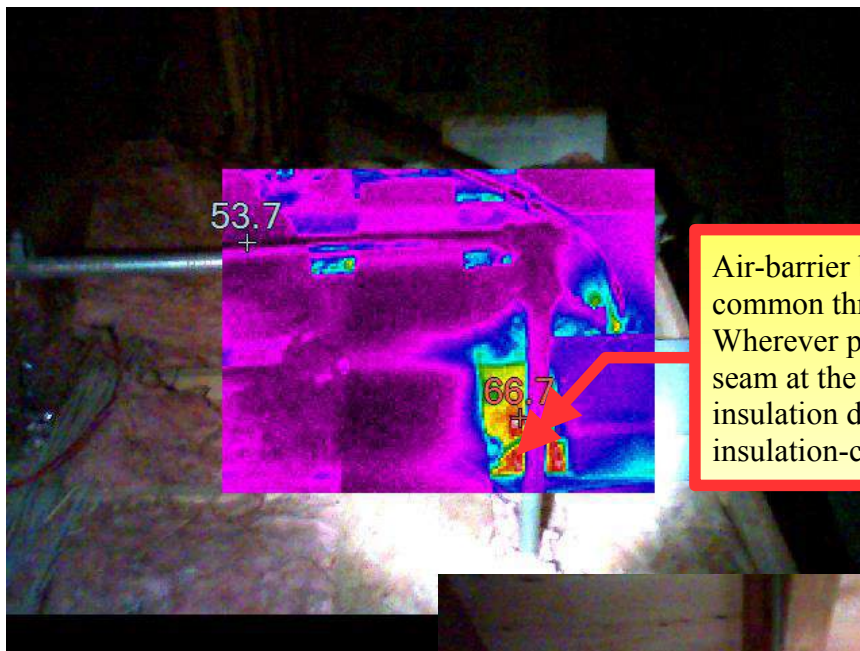
Priority	Retrofit/Air-sealing recommendations
High	<p>COMPUTER ROOM CEILING—<i>The ceiling is barely insulated and riddled with air-barrier breaches. A comprehensive retrofit will reduce heat and vapor loss into the attic above the central part of the building. And due to the ceiling's proximity to the attic-exhaust fan (which tends to increase exfiltration), air-sealing will likely have a disproportionate improvement.</i></p> <ul style="list-style-type: none"> • <i>Remove all existing fiberglass insulation and debris</i> • <i>Air-seal all ceiling penetrations with canfoam and/or caulking</i> • <i>Build foamboard or drywall boxes over recessed ceiling fixtures (fans/lights), sealed at edges and to the ceiling (convert light fixtures to LED).</i> • <i>Install insulation dams at sloped ceiling intersection to south, and along the edge of ceiling to north and west to retain the proposed insulation.</i> • <i>Install 16" loosefill cellulose over prepared ceiling surface (R-60).</i>

Air-barrier breaches such as this one are common throughout the entire attic. Wherever possible air-seal the penetration seam at the ceiling. If necessary create an insulation dam over the fixture to prevent insulation-contact.

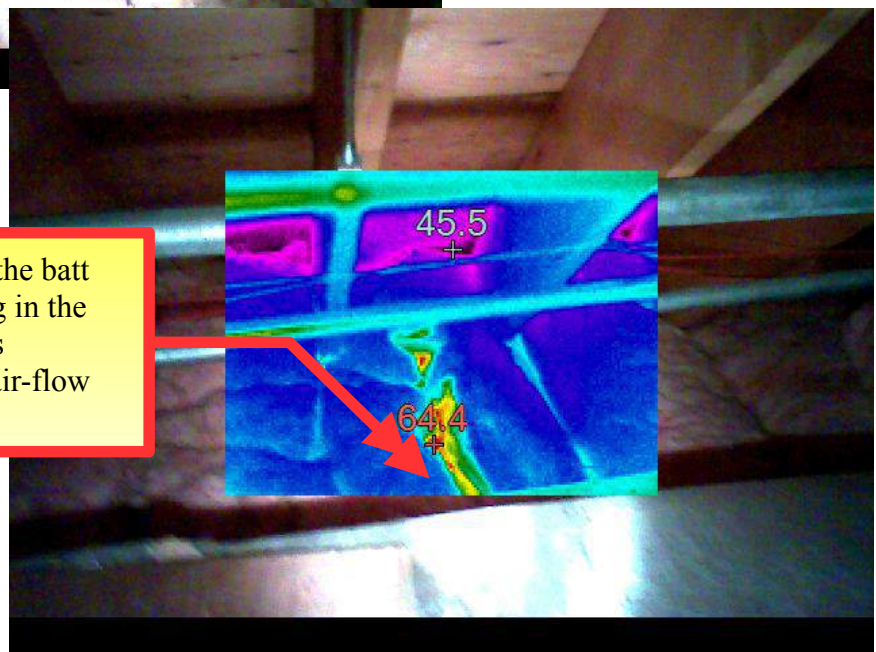
Gaps like these along the edges of the batt insulation allow convective looping in the air-space under the insulation—this accelerates heat-loss by increased air-flow through the insulation.

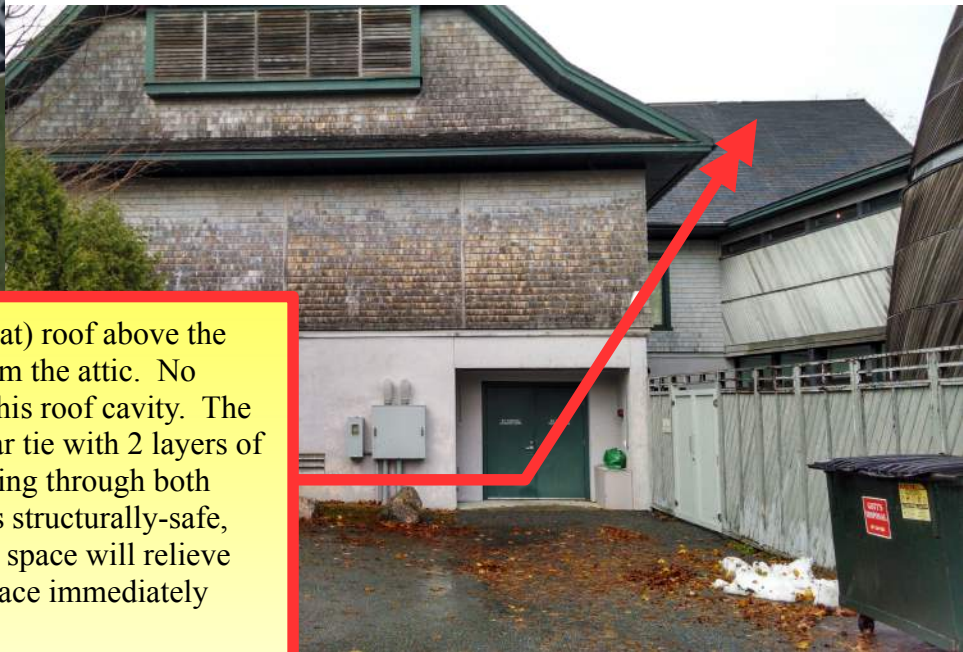
There is low-pitch (essentially flat) roof above the flat plywood deck as-viewed from the attic. No venting currently occurs out of this roof cavity. The deck is essentially a double collar tie with 2 layers of sandwiched 1/2" plywood. Cutting through both layers—with as large a hole as is structurally-safe, and connecting to the small attic space will relieve the vapor pressure in the attic space immediately above the exhibit room.

Type/ location	Recommendation
Attic	<ol style="list-style-type: none">1. Attic ventilation should be achieved through passive means rather than mechanical. Though no pressure-testing was done in the attic, it is quite possible that the exhaust fan, as it's set up, will pull outside air into the attic via the path of least resistance—or the larger open vents-areas. This means most outside air is pulled in through the soffit venting (east-facing), and likely some inside conditioned air is pulled through the larger holes in the air-barrier (chimney chase, kneewall spaces of original building).2. Unfortunately current attic ventilation, even with the exhaust fan doesn't likely pull enough air from the problem area (over the exhibit hall), mainly because there's no substantial supply of air to feed the exhaust fan.3. Ideally passive attic ventilation is designed to allow for a greater area of open venting down low throughout the attic, and a lesser amount at the very top of the attic. In this case the bottommost venting occurs in spots around the roof...some places unintentionally. While the uppermost venting occurs at the east eaves.4. Creating ventilation above the problem area is the ideal solution.5. Cut holes through the flat plywood decking/framing at the top of the attic space over the exhibit hall to allow airflow into roof cavities. Then either engineer ridge venting at the south-facing section of east/west ridge, or engineer/install a roof vent, built up through a curb to allow proper sealing with existing rubber roofing.
